Welded Continuous Frames & Their Components

Progress Report U

THE COLLAPSE STRENGTH OF A WELDED
SINGLE BAY FRAME

Fritz Laboratory Report No. 205D.5

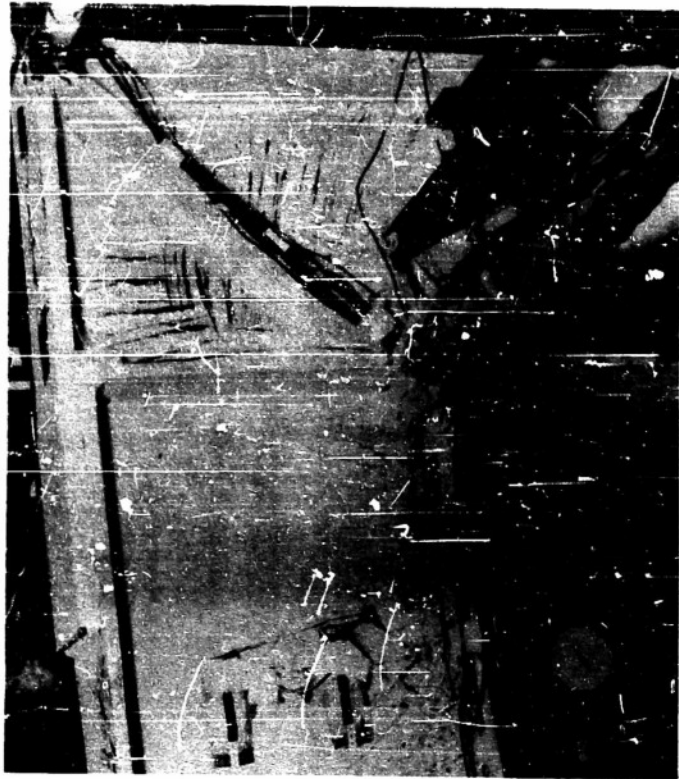
a. FIRST PLASTIC HINGE AT LEE KNEE

The elastic analysis shows that the first plastic hinge must form at point 6 (the leeward knee of the frame). Only one more hinge is needed to allow the frame to collapse. This second hinge will form at point 4 (the beam load point nearest the windward column). With the plastic modulus known ($Z_x = 48.1 \text{ in}^3$) and using the yield strength from coupon tests of the flange ($\sigma_y = 39,100 \text{ psi}$) the plastic moment, M_p , can be computed.

At the same time that the lateral buckle was observed in the top flange in the middle third of the beam, another type of instability was observed in the bottom flange of the beam at the lee knee in the form of flange crippling. The buckle occurred only in one-half of the flange with a wave length of about 3 or 4 inches. The center of the wave was about 4 in. from the intersection of beam and column. The yielded zone in which this buckle occurred can be seen in Fig. 9a. The buckle could be seen on the beam at the time the photograph was taken, but it is not easily discernible in the photograph. Though this buckle was observed soon after ultimate load had been reached, it did not appear to hinder the performance of the frame in any way. Certainly it did not have the weakening effect shown by the lateral buckle which occurred in the middle third of the beam.

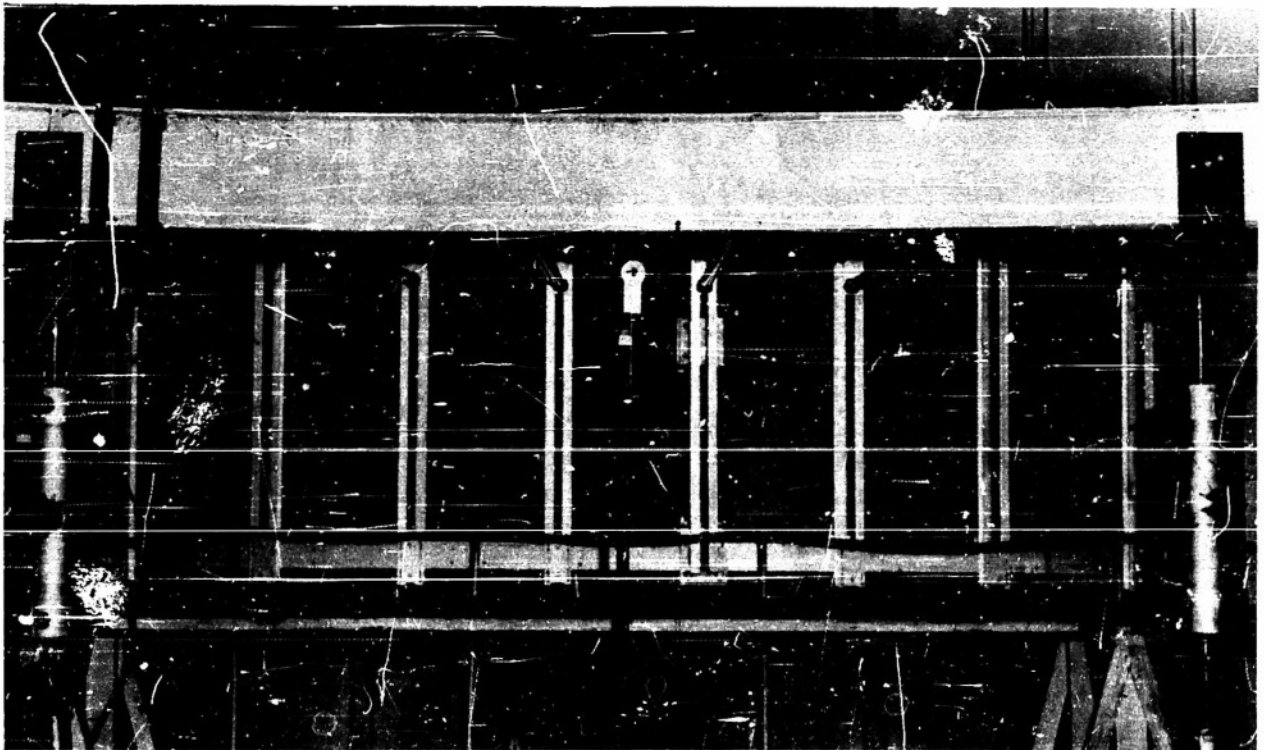
b. SECOND PLASTIC HINGE AT WINDWARD VERTICAL LOAD POINT

The first evidence of instability was observed by eye after the ultimate load had been reached and took the form of a lateral displacement of the compression flange of the beam near the second plastic hinge. The effect of this lateral buckle has already been discussed with regard to the drop in moment capacity of the beam in the region where the buckle occurred. This buckle took the form of a wave about 3 ft. long, but its displacement was prevented from increasing by the lateral supports which were attached to the beam at the intersection of web and flange.

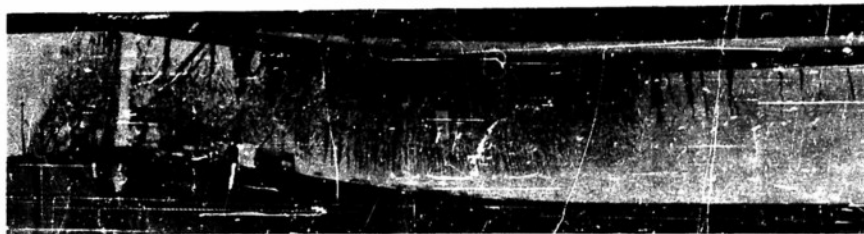
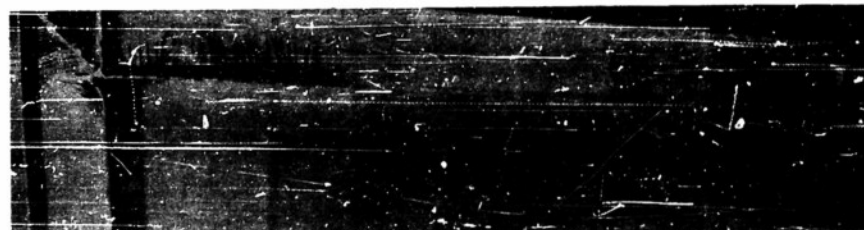
FIG. 12 LEE COLUMN AT FINAL LOAD

The third case of instability came when the unsupported compression flange of the lee column buckled laterally and the frame failed. This buckle showed some early signs of developing by the unequal yield pattern on the flange but apparently was held in check for some time by the lateral support attached to the compression flange at the intersection of beam and column. However, when the deflection at the center of the beam had reached a value of about 2.3 times its value at ultimate load, there was a distinct and rapid increase in the size of the buckle wave and a corresponding drop in load. However, even after this buckle occurred, the frame supported 87.2 per cent of its ultimate load but further straining produced decreasing load carrying capacity. Just before the lee column buckled the load was 95.3 per cent of the ultimate load and the deflection was 230 per cent of the deflection at ultimate load.

12. Final failure was brought about by lateral buckling of the lee column after the frame had supported virtually its ultimate load through deflections 230 per cent greater than those when ultimate load was first reached. The column had no lateral support except at its intersection with the beam and at its base.

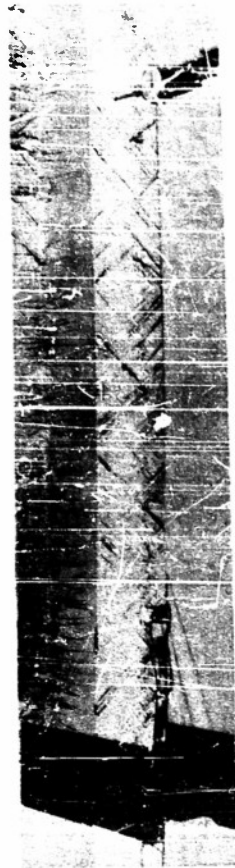
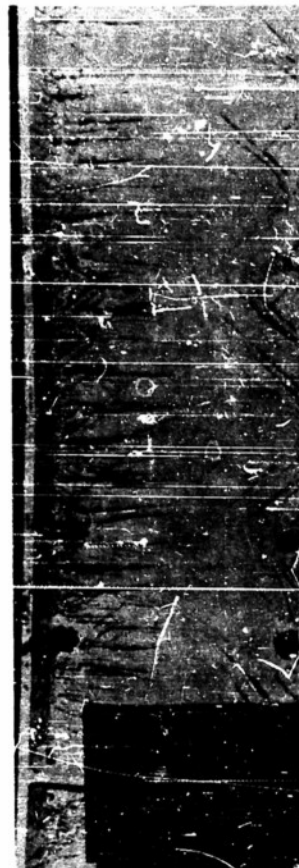
FIG. 13 REGION OF SECOND PLASTIC HINGE

reached. This reduction can possibly be explained by the fact that the beam tried to buckle laterally in this region soon after ultimate load was reached. This buckle could be observed by eye at the rotation indicated by the symbol "L.B.", but its effect was undoubtedly indicated much sooner by the drop in moment at this section and the drop in applied load seen on Fig. 4. The effect of this lateral buckling action was quickly overcome as the lateral supports in the region were sufficient to prevent increased lateral movement. The moment at the section increased again and exceeded the previous maximum value.

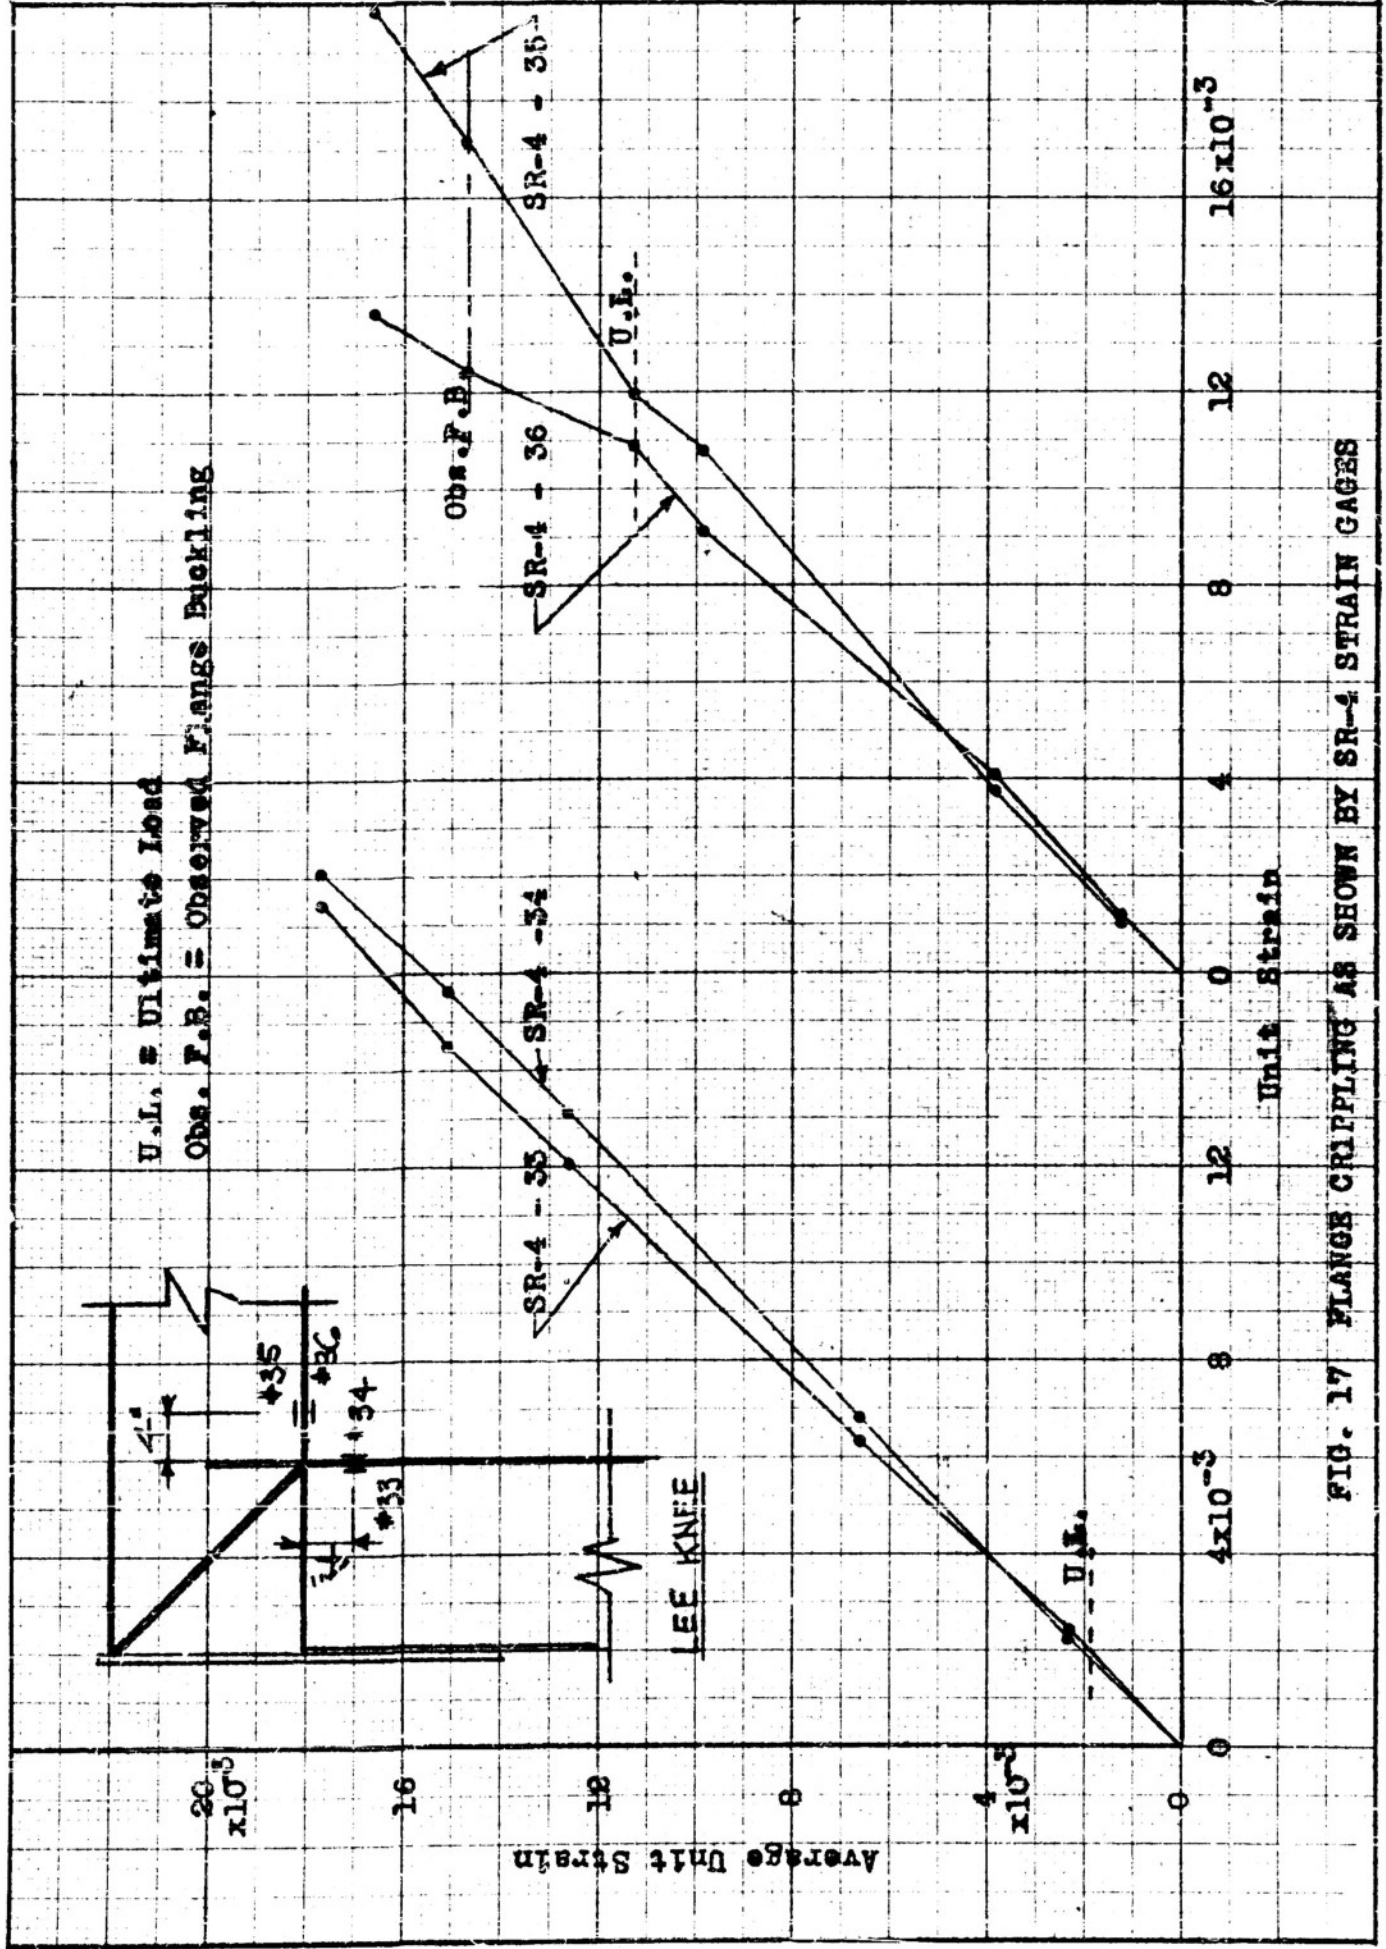
FIG. 17 FLANGE CRIPPLING AS SHOWN BY SR-4 STRAIN GAGES

second method of detecting the flange crippling was the use of two SR-4 electrical strain gages mounted opposite one another on the inner and outer surfaces of the compression flange. Three such indicators were used in the region of the lee knee at the location shown on Fig. 16. The center of the visually observed flange buckle wave coincided with the location of SR-4 gages 35 and 36.

at the visually observed buckle and their comparison is of particular interest. The gage readings follow one another very well until a unit strain of about 11×10^{-3} in. per in. was reached where upon the two curves diverge. This would indicate flange crippling. The strain level at which the buckle was observed is marked Obs. F.B. (Observed Flange Buckle). The curves plotted from SR-4 gages 33 and 34 do not diverge and no flange buckling was observed even though the strain level was as high in their case as in the case of gages 35 and 36.
